Manhole Inspection Summary

Manhole # S23EE1005MH

Location Address: **3920 BUENA VISTA AVE**

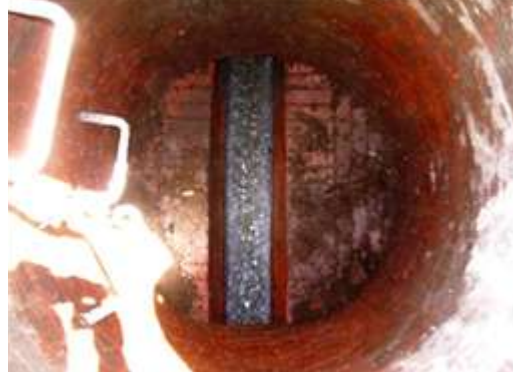
Top View

Evidence of surcharge - Bench debris.

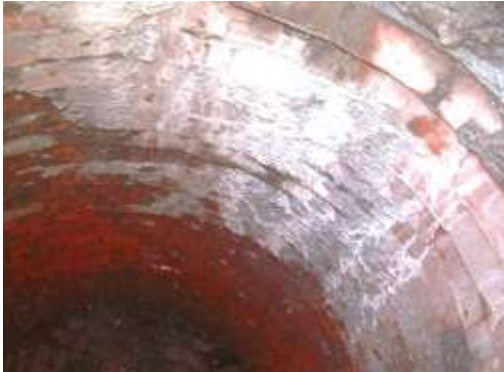
Defect

Frame leaks. Adjustment and Barrel infiltration.

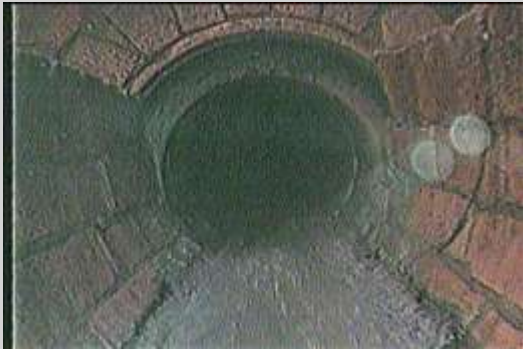
12 in. Circular Gravity Sewer Pipe Out @ 12 O'Clock

Infiltration: **Evidence** Pipe Seal Cond: **Unknown**
